## Robert Poole Building #056 Additions and Renovations

# Geotechnical Engineering Study

Robert Poole Additions & Renovations Building #056  
*Baltimore City Public Schools*  
Baltimore, Maryland

Re: **Geotechnical Engineering Study**  
**Robert Poole Additions & Renovations Building #056**  
Baltimore City Public Schools  
Baltimore, Maryland

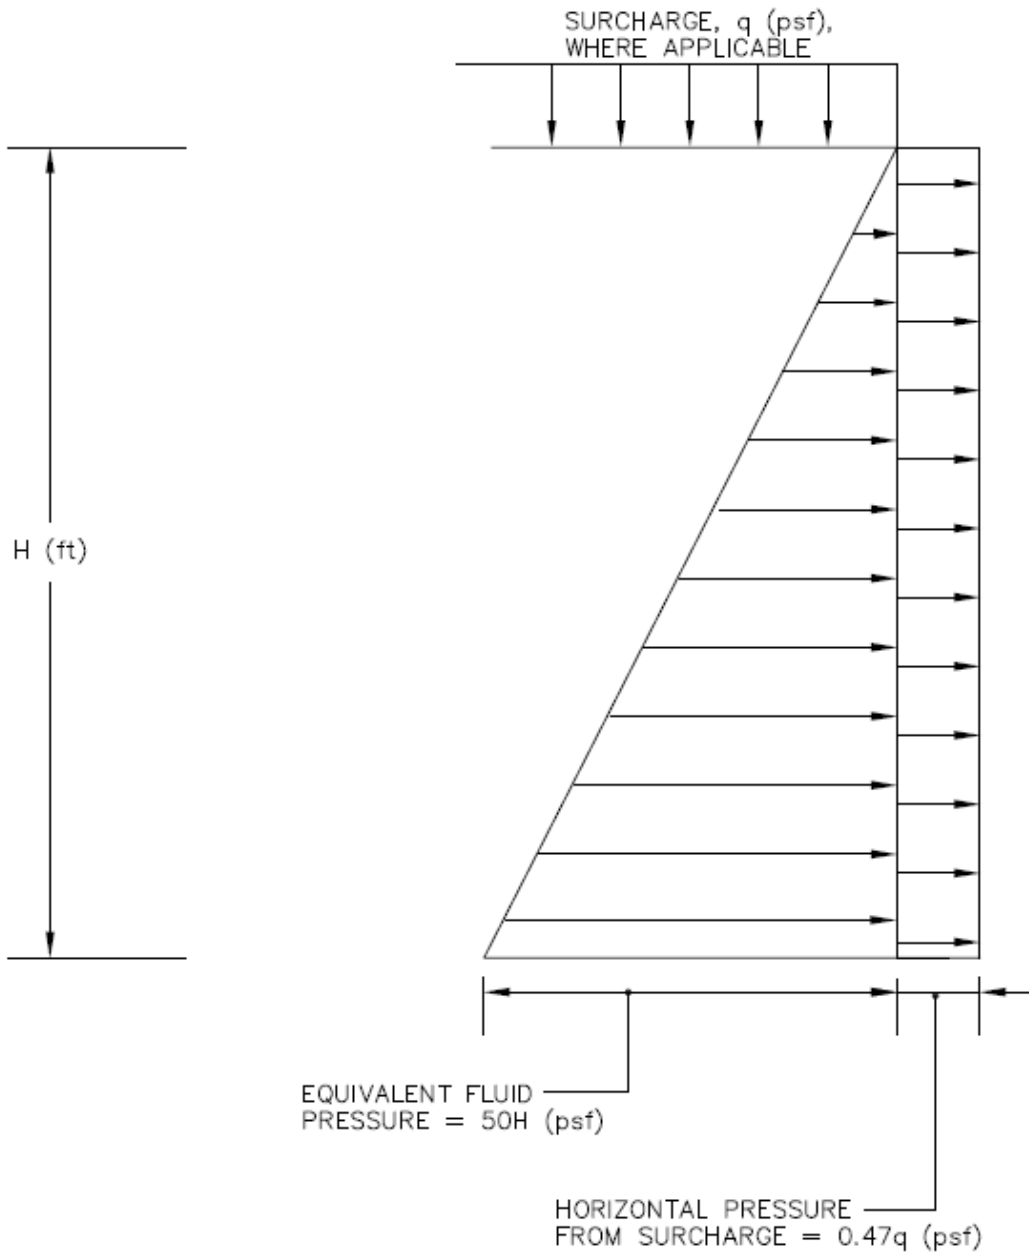
- NOTES:
- 1) Earth Pressure Diagram shown assumes full drainage of hydrostatic pressure.
  - 2) See report for backfill material requirements.

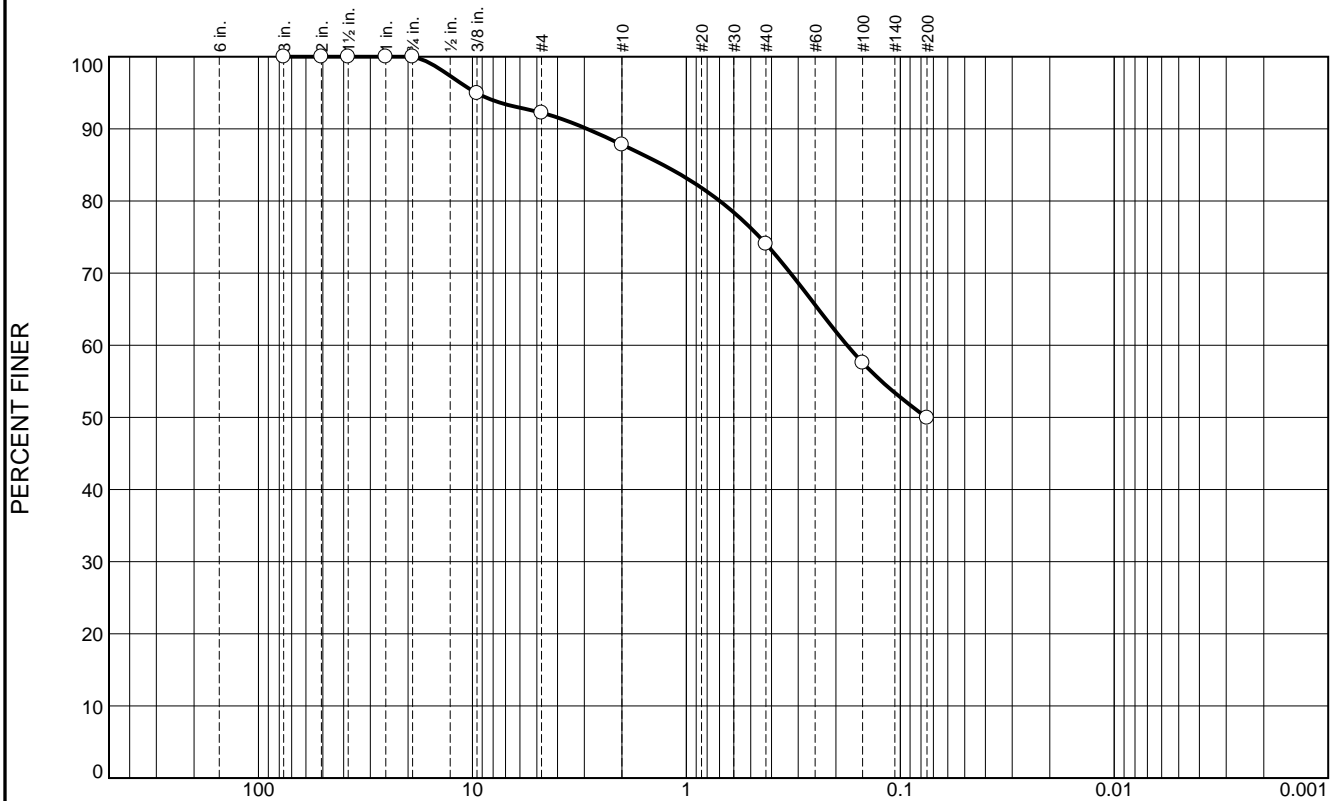
# Particle Size Distribution Report

% +3"	% Gravel	% Sand	% Silt
0.0	7.8	42.3	49.9

SIEVE SIZE	PERCENT FINER	SPEC.* PERCENT	PASS? (X=NO)
3"	100.0		
2"	100.0		
1 - 1/2"	100.0		
1"	100.0		
3/4"	100.0		
3/8"	94.9		
#4	92.2		
#10	87.8		
#40	74.1		
#100	57.6		
#200	49.9

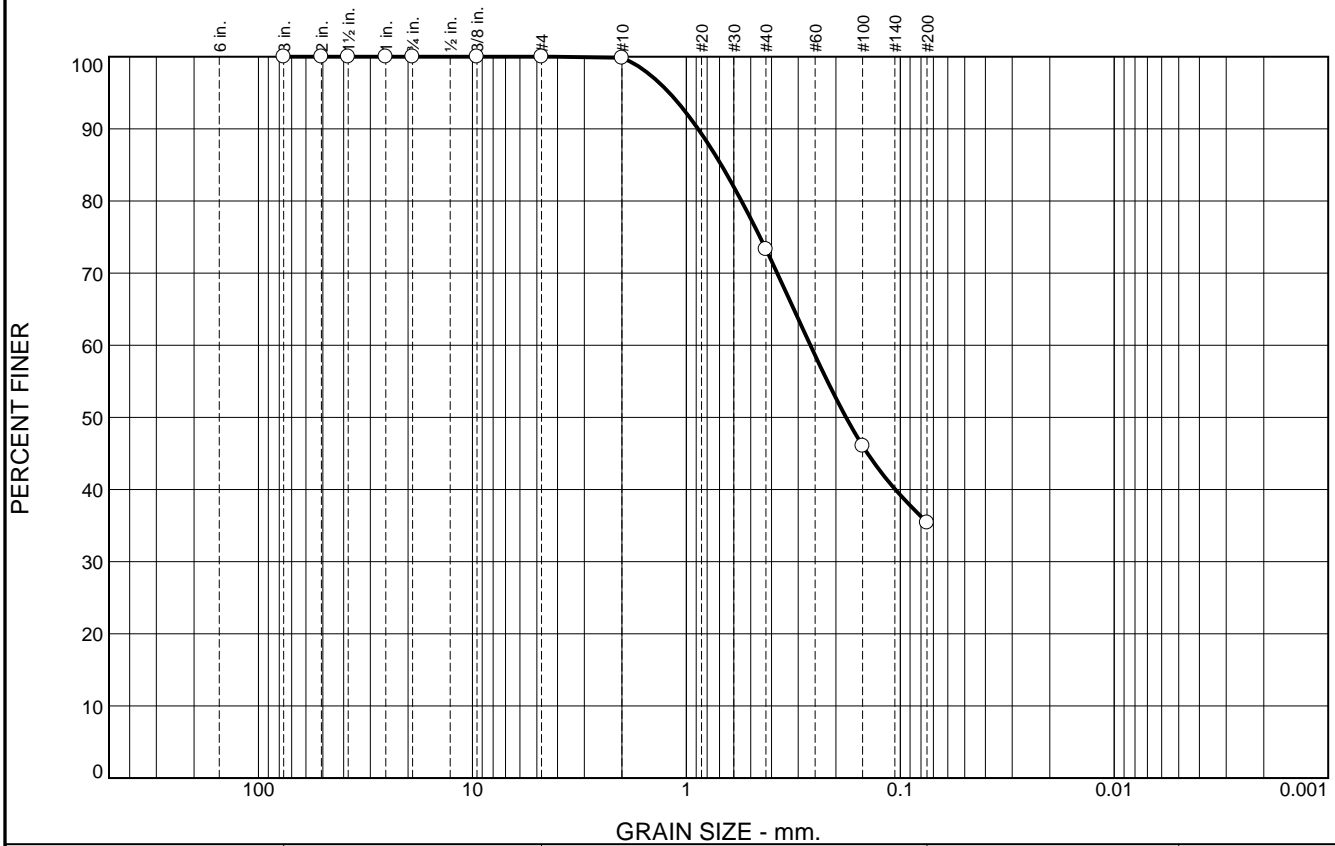
# Particle Size Distribution Report

% +3"	% Gravel	% Sand	% Silt
0.0	0.0	64.6	35.4

SIEVE SIZE	PERCENT FINER	SPEC.* PERCENT	PASS? (X=NO)
3"	100.0		
2"	100.0		
1 - 1/2"	100.0		
1"	100.0		
3/4"	100.0		
3/8"	100.0		
#4	100.0		
#10	99.8		
#40	73.3		
#100	46.1		
#200	35.4

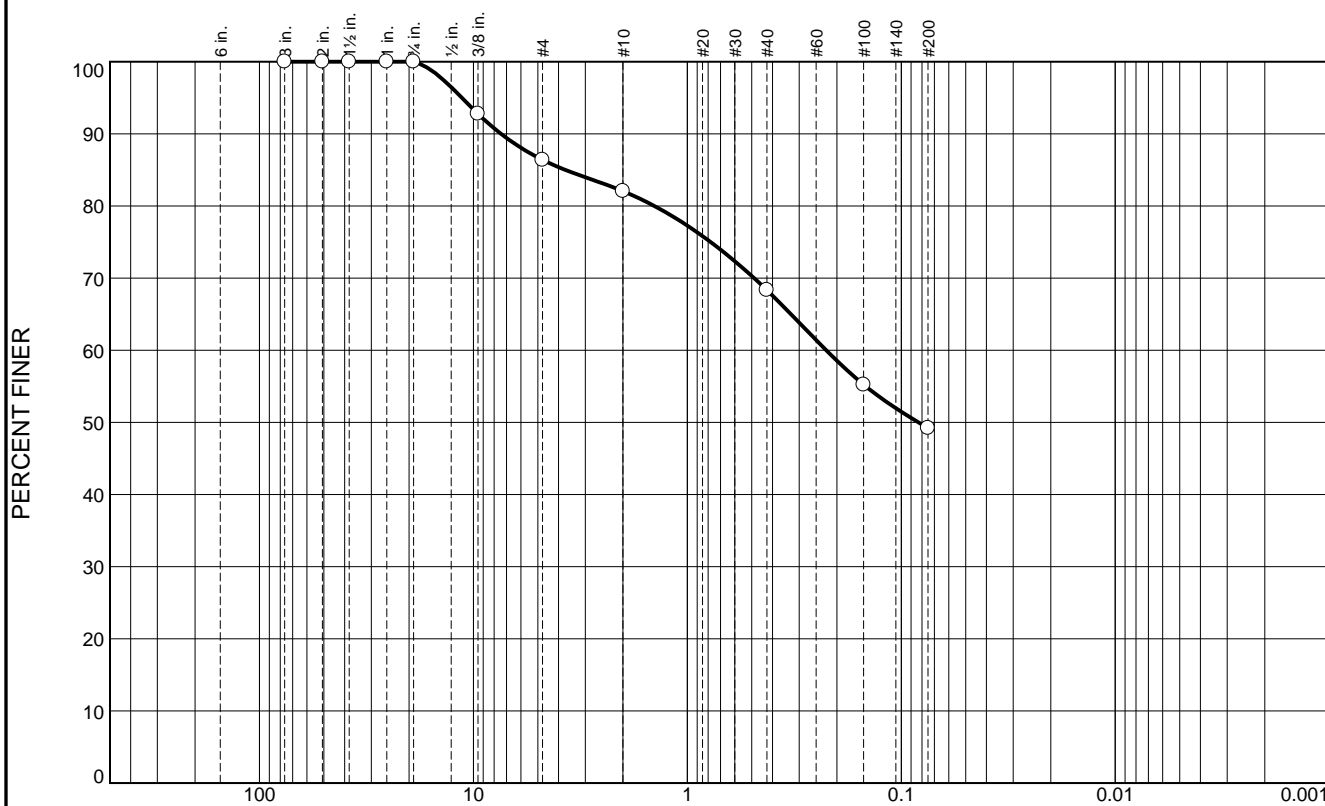
# Particle Size Distribution Report

% +3"	% Gravel	% Sand	% Silt	% Clay
0.0	13.6	37.2	49.2

SIEVE SIZE	PERCENT FINER	SPEC.* PERCENT	PASS? (X=NO)
3"	100.0		
2"	100.0		
1 - 1/2"	100.0		
1"	100.0		
3/4"	100.0		
3/8"	92.8		
#4	86.4		
#10	82.1		
#40	68.3		
#100	55.2		
#200	49.2

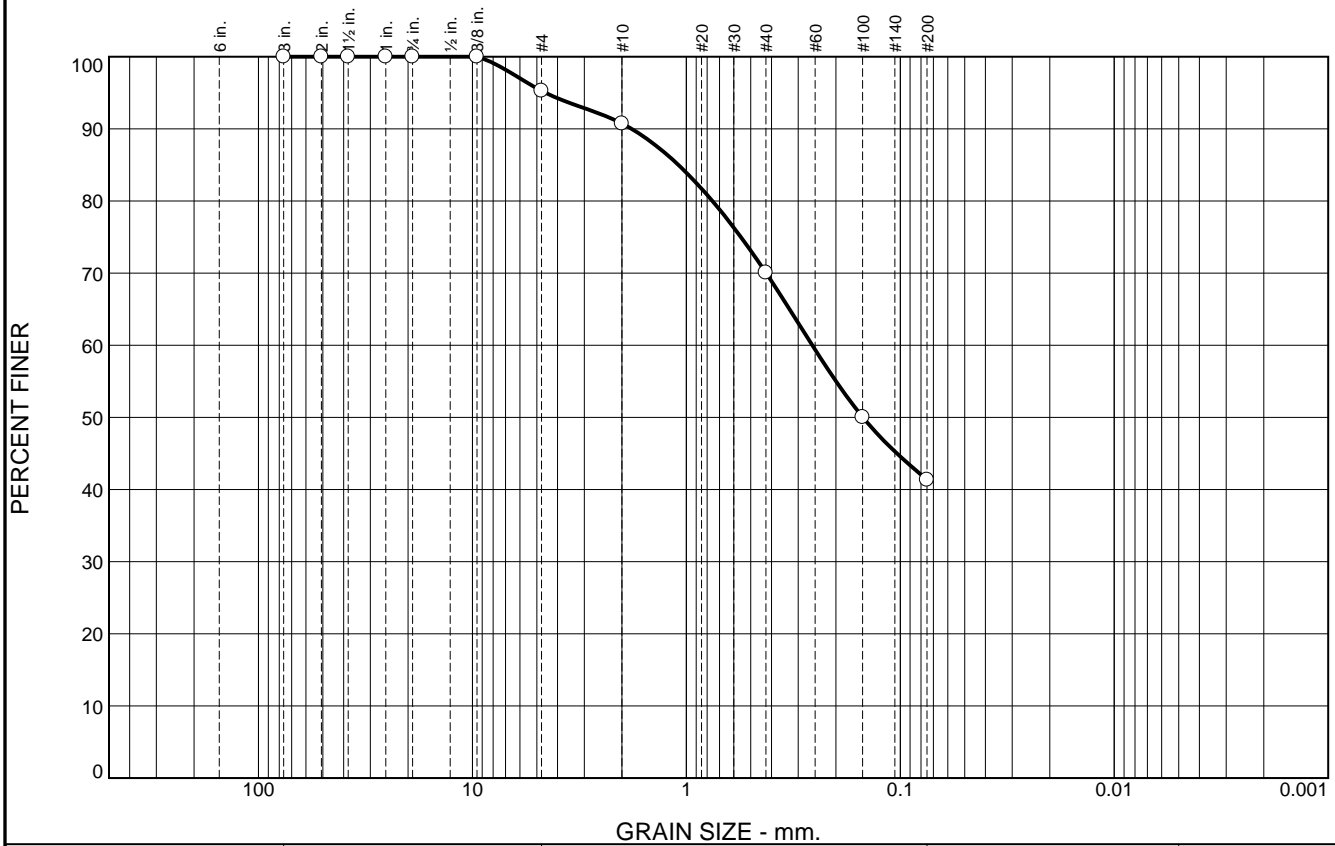
# Particle Size Distribution Report

% +3"	% Gravel	% Sand	% Silt	% Clay
0.0	4.7	54.0	41.3

SIEVE SIZE	PERCENT FINER	SPEC.* PERCENT	PASS? (X=NO)
3"	100.0		
2"	100.0		
1 - 1/2"	100.0		
1"	100.0		
3/4"	100.0		
3/8"	100.0		
#4	95.3		
#10	90.7		
#40	70.1		
#100	50.0		
#200	41.3

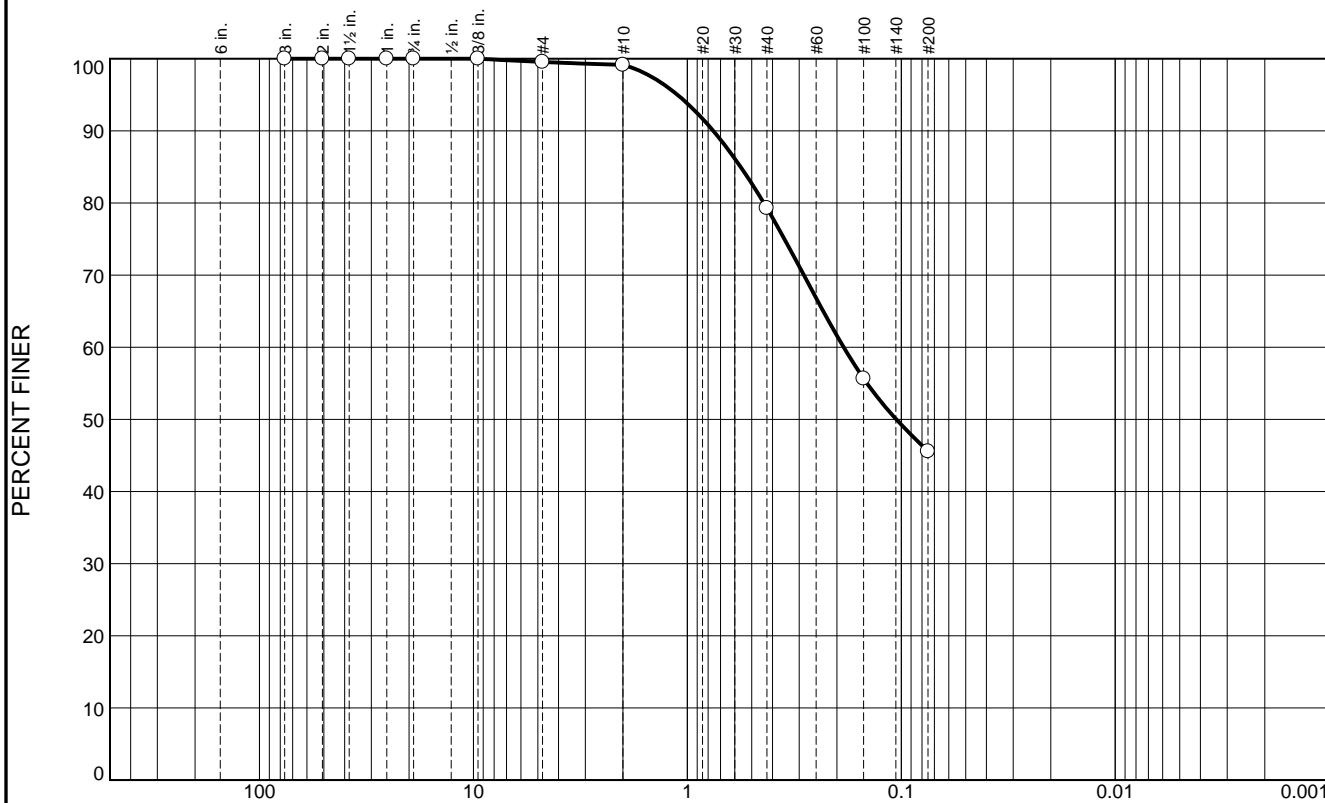
# Particle Size Distribution Report

% +3"	% Gravel	% Sand	% Silt	% Clay
0.0	0.5	53.9	45.6

SIEVE SIZE	PERCENT FINER	SPEC.* PERCENT	PASS? (X=NO)
3"	100.0		
2"	100.0		
1 - 1/2"	100.0		
1"	100.0		
3/4"	100.0		
3/8"	100.0		
#4	99.5		
#10	99.1		
#40	79.3		
#100	55.7		
#200	45.6

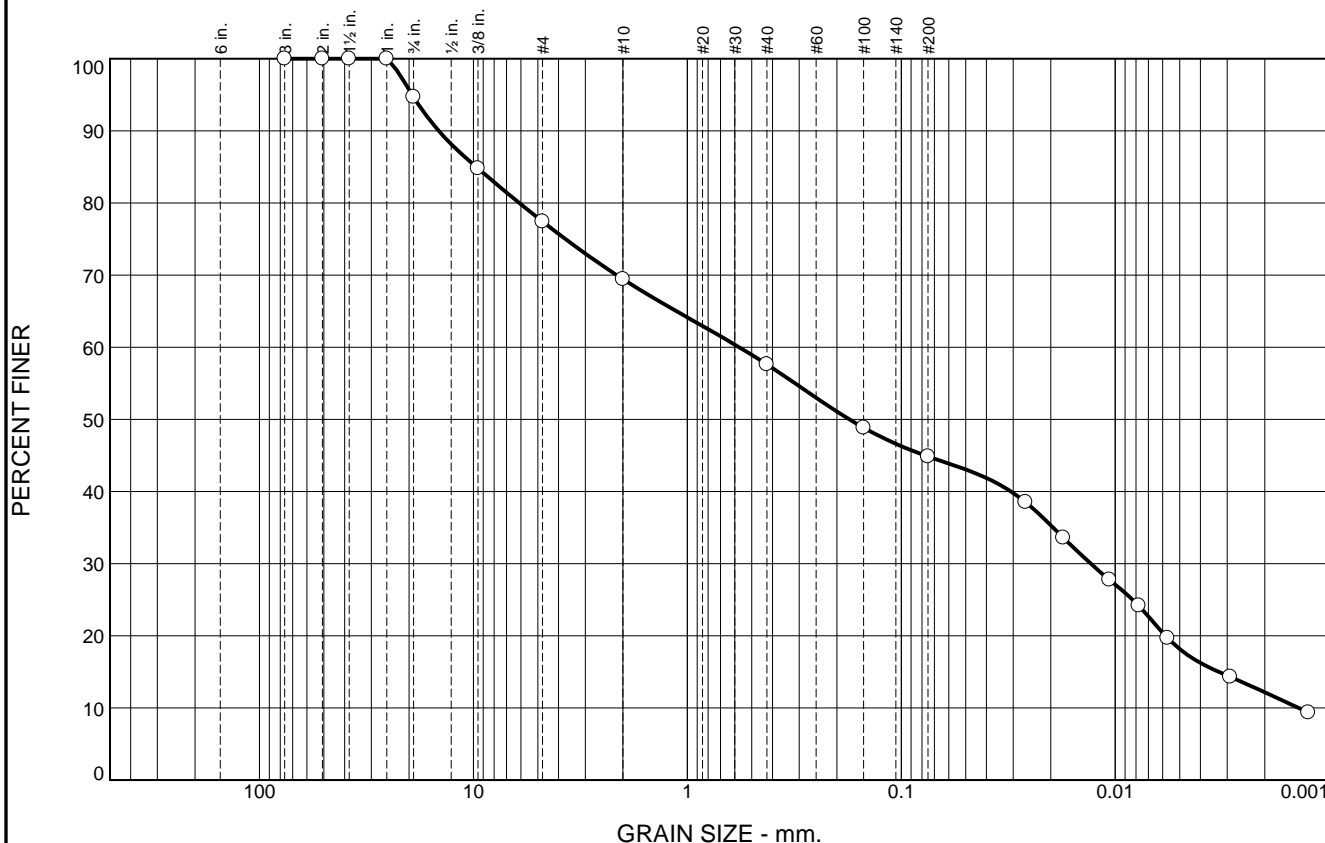
# Particle Size Distribution Report

<b>% +3"</b>	<b>% Gravel</b>	<b>% Sand</b>	<b>% Silt</b>	<b>% Clay</b>
0.0	22.6	32.5	26.7	18.2

SIEVE SIZE	PERCENT FINER	SPEC.* PERCENT	PASS? (X=NO)
3"	100.0		
2"	100.0		
1 - 1/2"	100.0		
1"	100.0		
3/4"	94.7		
3/8"	84.8		
#4	77.4		
#10	69.4		
#40	57.6		
#100	48.8		
#200	44.9

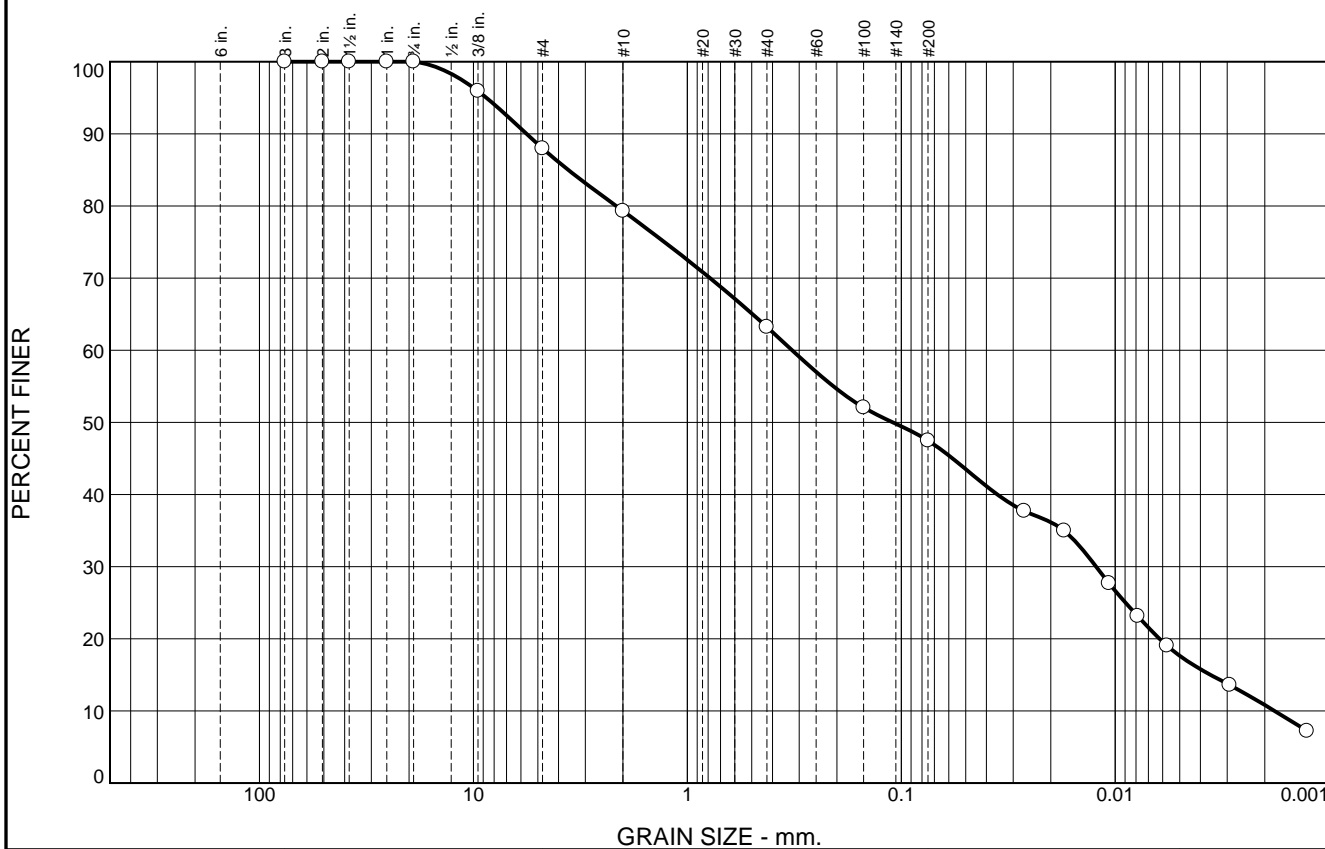
# Particle Size Distribution Report

% +3"	% Gravel	% Sand	% Silt	% Clay
0.0	12.0	40.5	29.8	17.7

SIEVE SIZE	PERCENT FINER	SPEC.* PERCENT	PASS? (X=NO)
3"	100.0		
2"	100.0		
1 - 1/2"	100.0		
1"	100.0		
3/4"	100.0		
3/8"	95.9		
#4	88.0		
#10	79.3		
#40	63.2		
#100	52.1		
#200	47.5

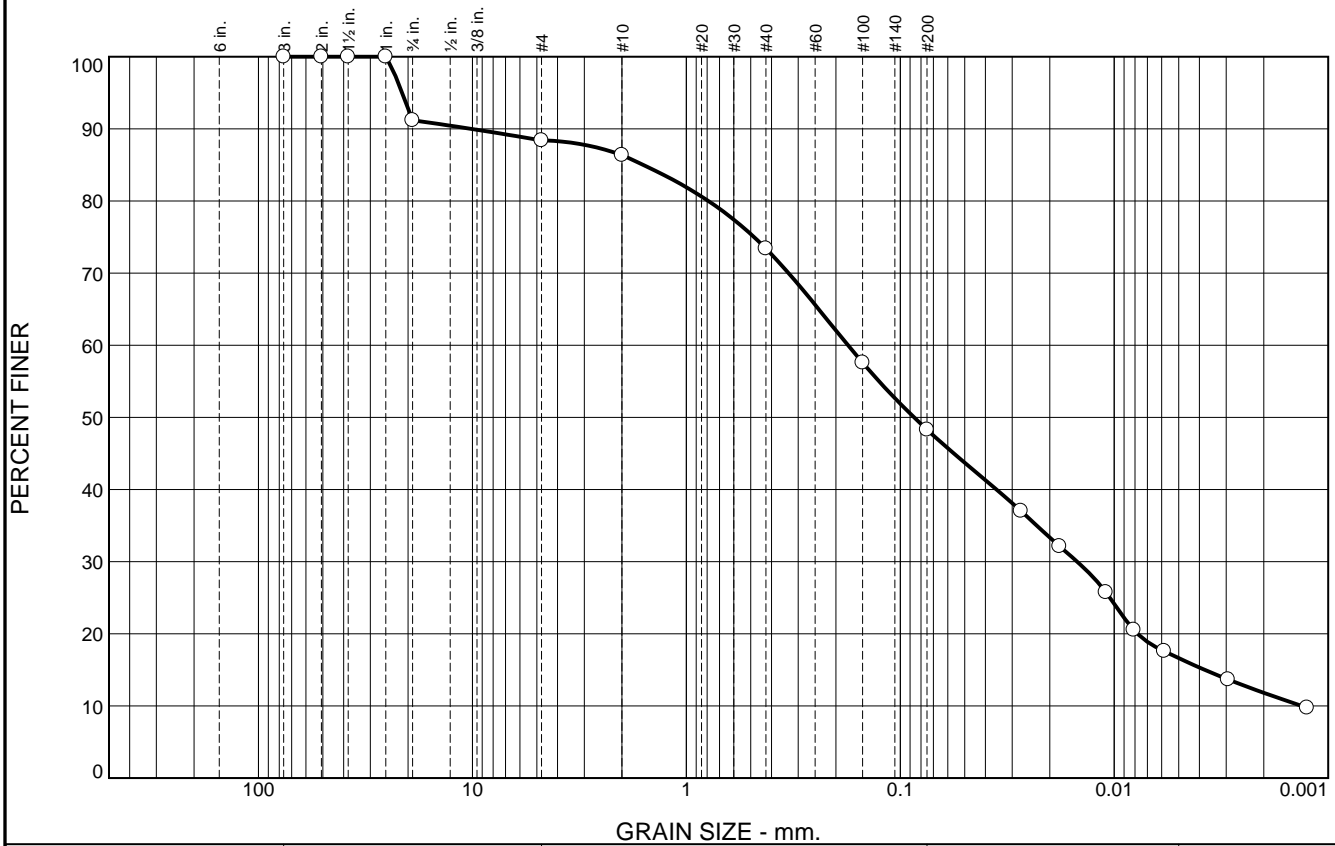
# Particle Size Distribution Report

<b>% +3"</b>	<b>% Gravel</b>	<b>% Sand</b>	<b>% Silt</b>	<b>% Clay</b>
0.0	11.6	40.1	31.7	16.6

SIEVE SIZE	PERCENT FINER	SPEC.* PERCENT	PASS? (X=NO)
3"	100.0		
2"	100.0		
1 - 1/2"	100.0		
1"	100.0		
3/4"	91.2		
#4	88.4		
#10	86.4		
#40	73.4		
#100	57.6		
#200	48.3

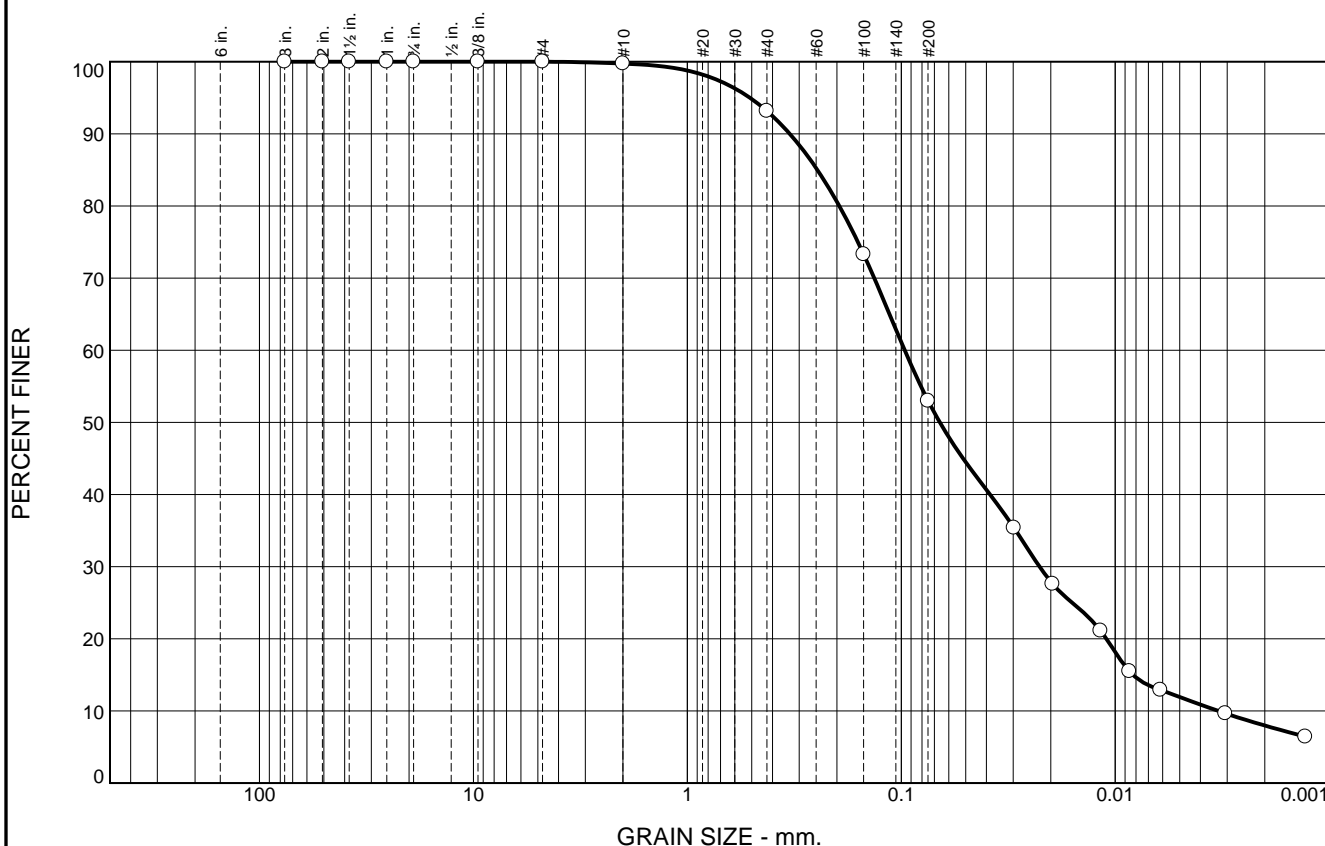
# Particle Size Distribution Report

% +3"	% Gravel	% Sand	% Silt	% Clay
0.0	0.0	47.0	41.1	11.9

SIEVE SIZE	PERCENT FINER	SPEC.* PERCENT	PASS? (X=NO)
3"	100.0		
2"	100.0		
1 - 1/2"	100.0		
1"	100.0		
3/4"	100.0		
3/8"	100.0		
#4	100.0		
#10	99.7		
#40	93.2		
#100	73.3		
#200	53.0

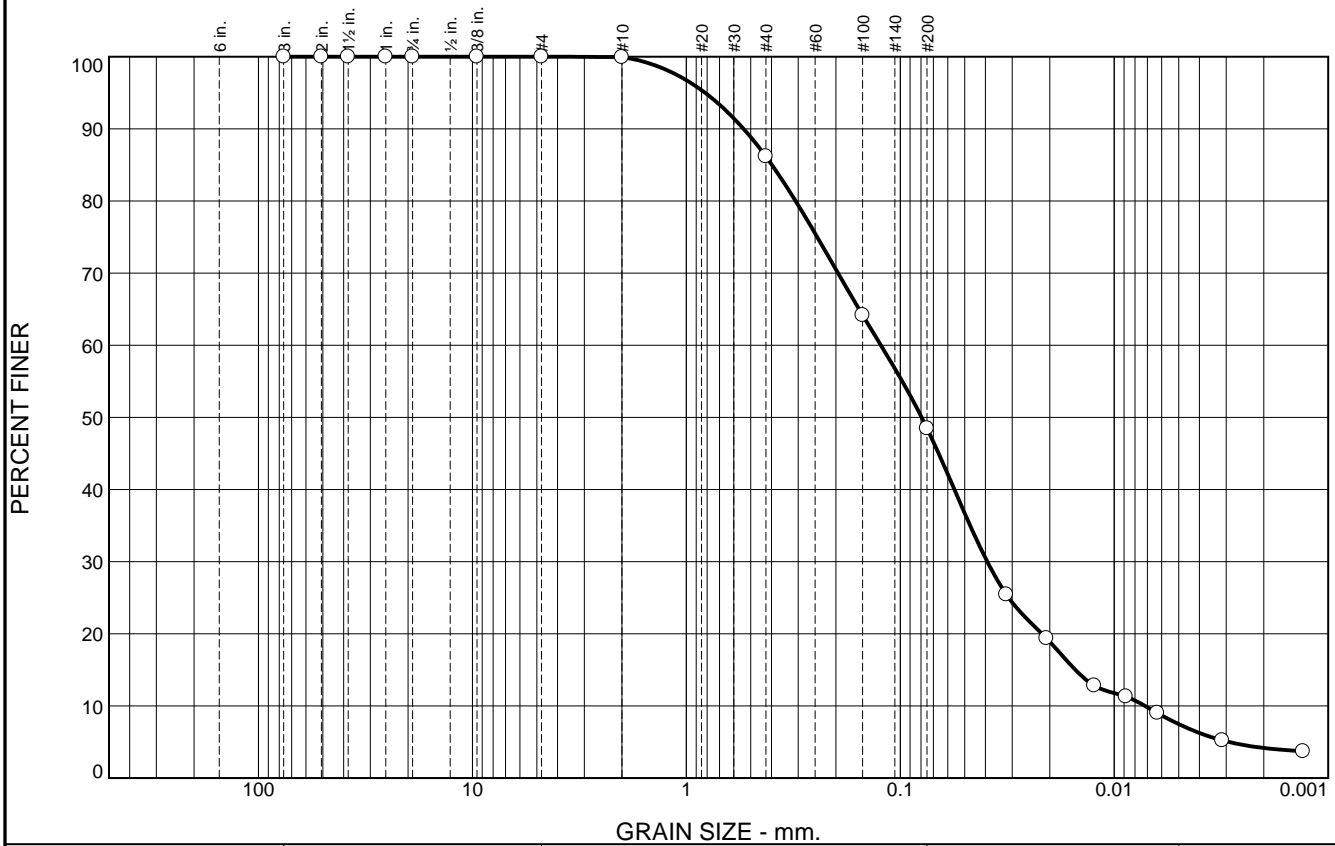
# Particle Size Distribution Report

<b>% +3"</b>	<b>% Gravel</b>	<b>% Sand</b>	<b>% Silt</b>	<b>% Clay</b>
0.0	0.0	51.5	41.0	7.5

SIEVE SIZE	PERCENT FINER	SPEC.* PERCENT	PASS? (X=NO)
3"	100.0		
2"	100.0		
1 - 1/2"	100.0		
1"	100.0		
3/4"	100.0		
3/8"	100.0		
#4	100.0		
#10	99.9		
#40	86.2		
#100	64.2		
#200	48.5

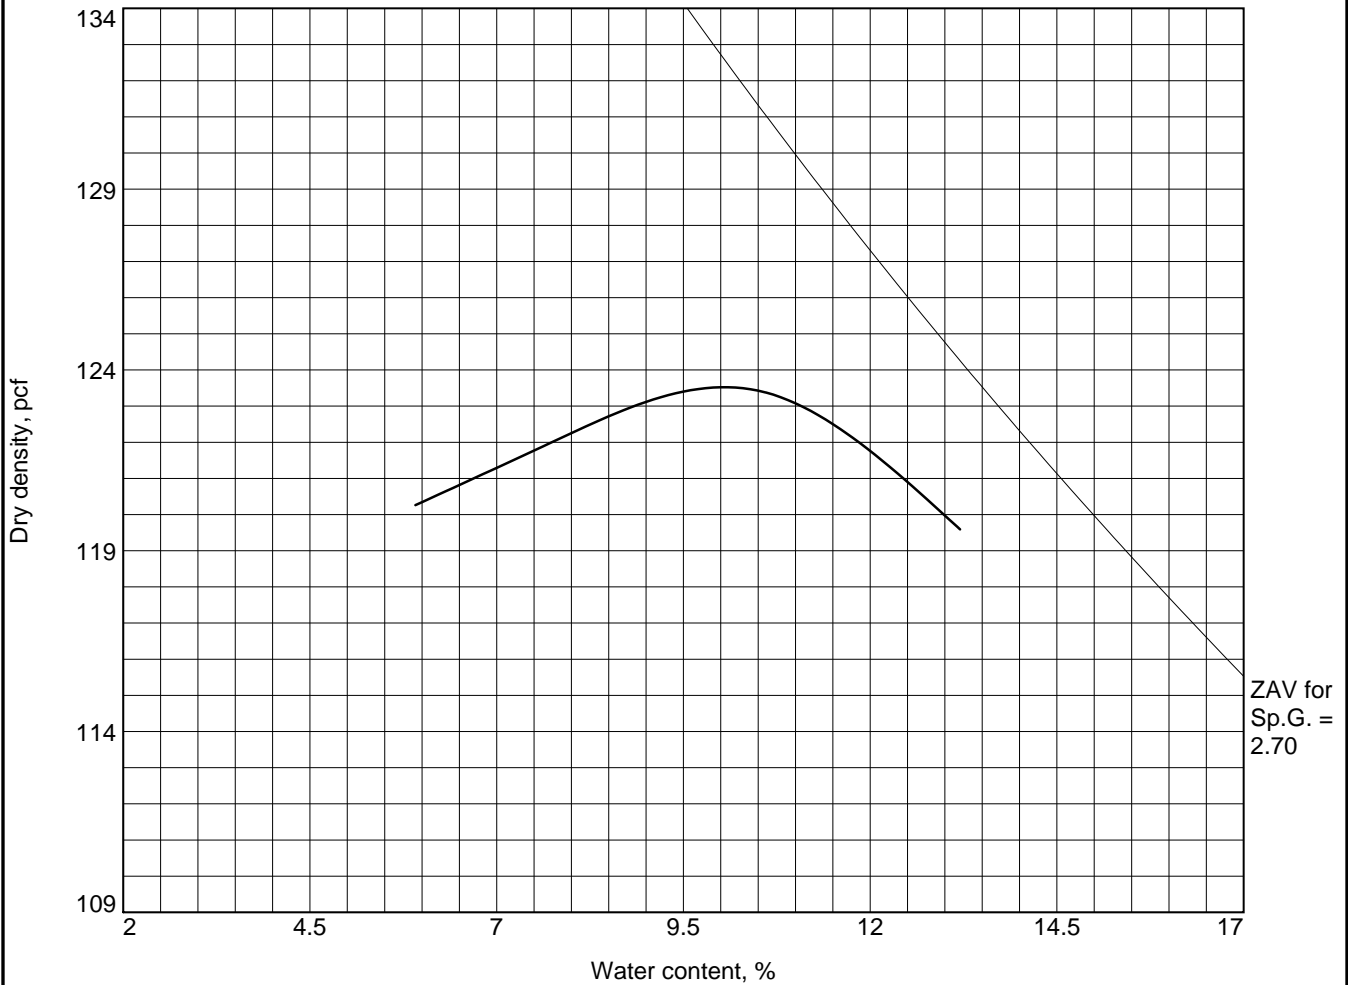
# LABORATORY COMPACTION TEST REPORT

Test specification: AASHTO T 180 Method C Modified

Elev/ Depth	Classification		Nat. Moist.	Sp.G.	LL	PI	% > 3/4 in.	% < No.200
	USCS	AASHTO						
1.0'-10.0'	SC	A-4(2)	18.5	2.70	30	10	0.0	45.6

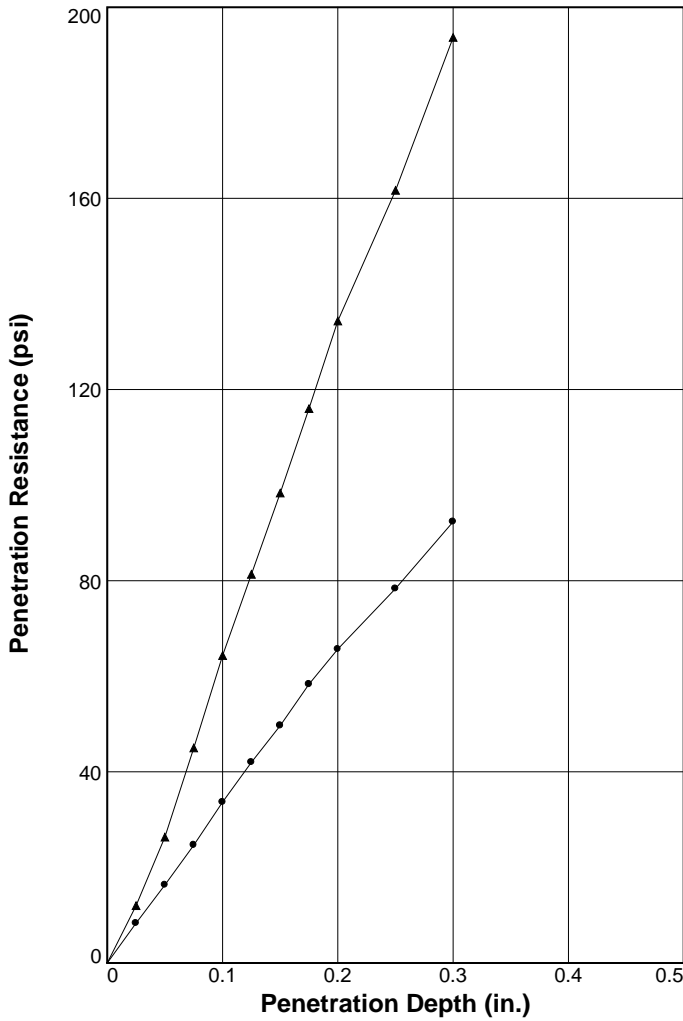
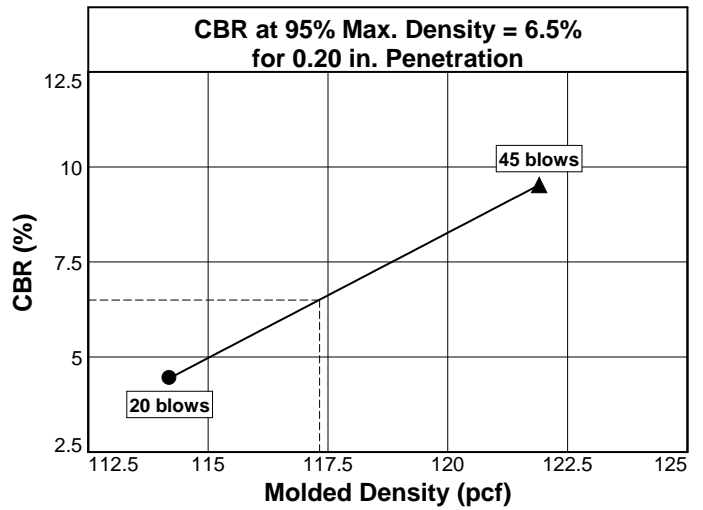
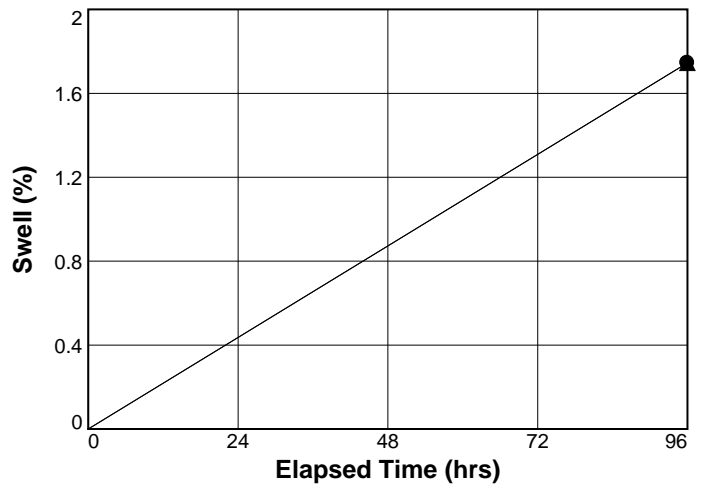
# BEARING RATIO TEST REPORT

## ASTM D 1883-99

Molded			Soaked			CBR (%)		Linearity Correction (in.)	Surcharge (lbs.)	Max. Swell (%)
	Density (pcf)	Percent of Max. Dens.	Moisture (%)	Density (pcf)	Percent of Max. Dens.	Moisture (%)	0.10 in.	0.20 in.			
1 ○	114.2	92.5	9.9	112.2	90.9	21.4	3.5	4.4	0.004	10	1.7
2 △	121.9	98.7	9.9	119.8	97	17.9	7.5	9.5	0.016	10	1.7
3 □

Material Description	USCS	Max. Dens. (pcf)	Optimum Moisture (%)	LL	PI
	Brown clayey sand	SC	123.5	10.0	30
